S.No.	Problem area	Possible solutions
3.	<p data-bbox="443 250 726 285">Single pit to twin pit</p>

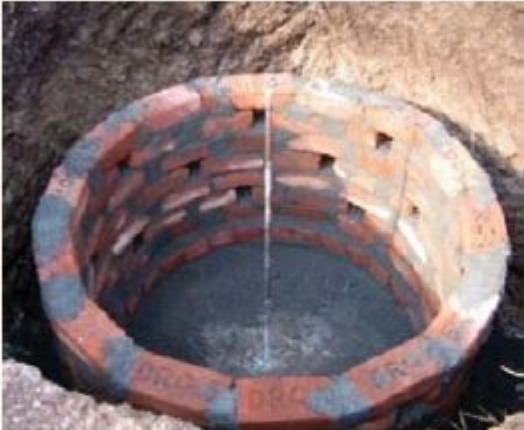
<ul style="list-style-type: none"> <li data-bbox="1062 250 1745 415">▶ Stop the use of toilet for two days. Meanwhile, those households whose toilets are being retrofitted can use neighbourhood toilets or community toilets.</li> <li data-bbox="1062 448 1730 565">▶ Flush the toilet thoroughly with water so that any faecal matter present in the pan or pipe is cleared.</li> <li data-bbox="1062 597 1682 675">▶ A second pit (01 m x 01m) may be dug at a distance of one metre from the first pit.</li> <li data-bbox="1062 708 1745 915">▶ The pipe connecting the first pit with the junction chamber may be cut five inches from the rear wall. The cut should be a feet long from the 5 inch mark. Do not interfere with the remaining portion of the pipe.</li> <li data-bbox="1062 948 1703 1026">▶ Y- Junction of 01ft x 01ft (inner size) may be constructed and connected to both the pits.</li> </ul>
